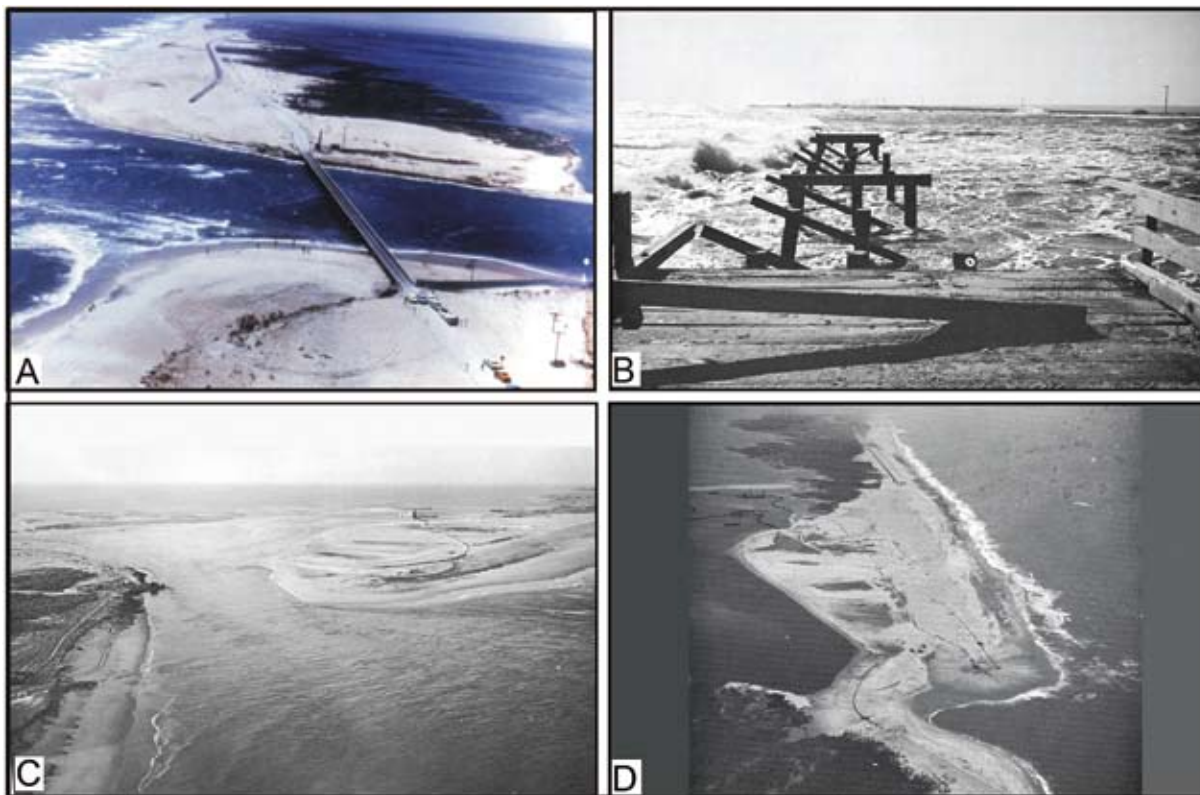
Figure 15. (A) Buxton Inlet as it appeared following construction of the Highway 12 bridge shortly after opening in 1962 (photograph courtesy of National Park Service Archives at Cape Hatteras National Park, Manteo). (B) A photograph of Buxton Inlet following destruction of the bridge during a nor'easter in December, 1962 (USACE, 1963). (C) An oblique aerial photograph of Buxton Inlet in 1963 showing the dredging and filling operation; note the pipeline feeding sand to the beach from dredging operations in the sound (USACE, 1963). (D) An oblique aerial photograph showing the Buxton Inlet location following inlet closure by the USACE (USACE, 1963).

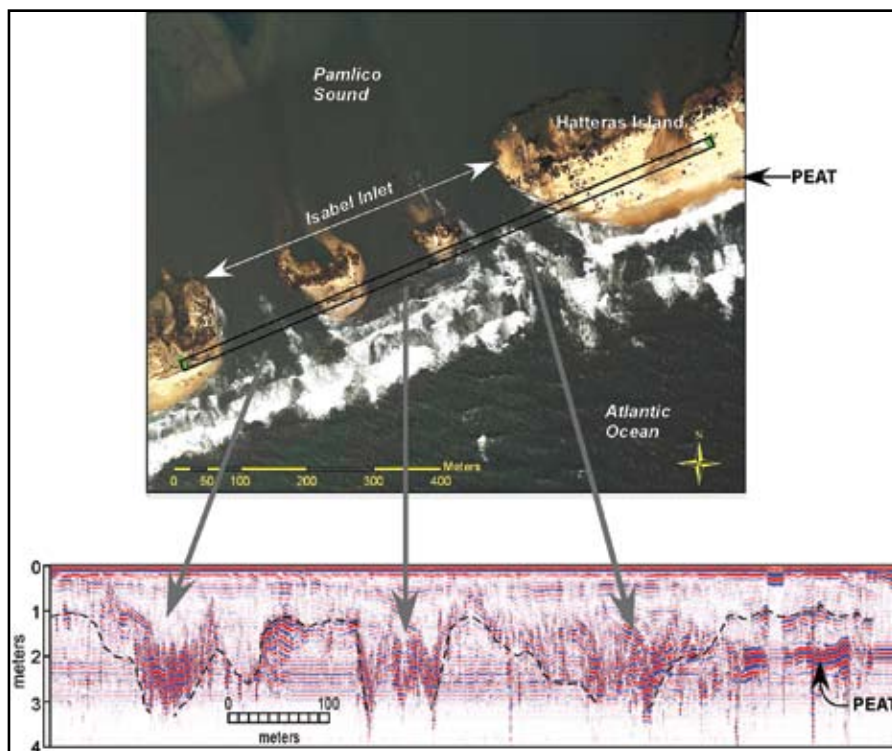
Figure 16. (A) An aerial photograph of Isabel Inlet indicating the location of the ground penetrating radar survey following filling of the channels, shown in B) (NC State Database). Note the location of three channels that developed, which are seen within the GPR data. For clarity, channel flanks are defined with the dashed black line. Also, note the occurrence of peat in the subsurface, and exposed on the shoreface.
